Fukushima Accident : An overview

1. Design of Fukushima NPP

3. Event Progression

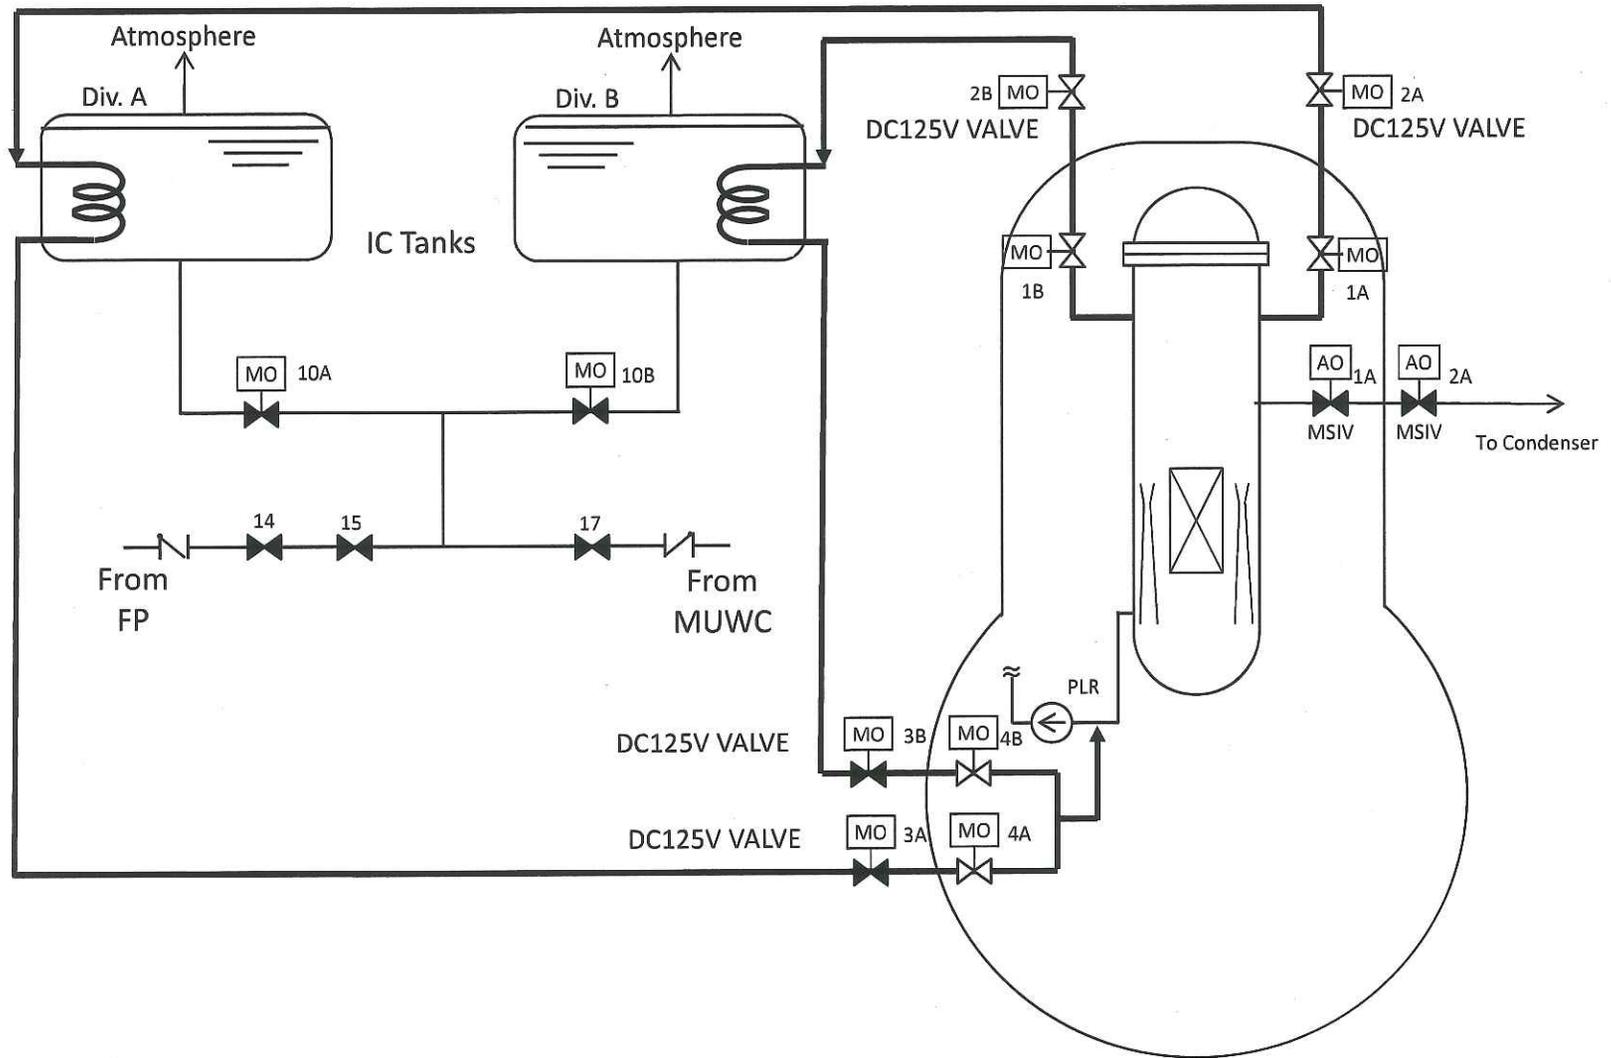
Schematic of Isolation Condenser (Unit 1)

Design Feature of Isolation Condenser (Unit 1)

Item	Description
Purpose	<ul style="list-style-type: none">•Cool down RPV water during isolation event (MSIV closure) without losing RPV water inventory
Function	<ul style="list-style-type: none">•After reactor isolation, sends reactor steam into condenser•After heat exchange at condenser, returns condensed water into reactor
System configuration	<ul style="list-style-type: none">•Two division systems with Condensers, isolation valves, piping [see next slide]•NOFO isolation MO valves in steam lines•NCFC isolation MO valve in return lines•All valves can be operated by DC power
Capacity	<ul style="list-style-type: none">•Two ICs can remove heat load of 6% of rated power•IC Pool capacity is good enough for 10 hour operation without AC power for makeup water into IC tank

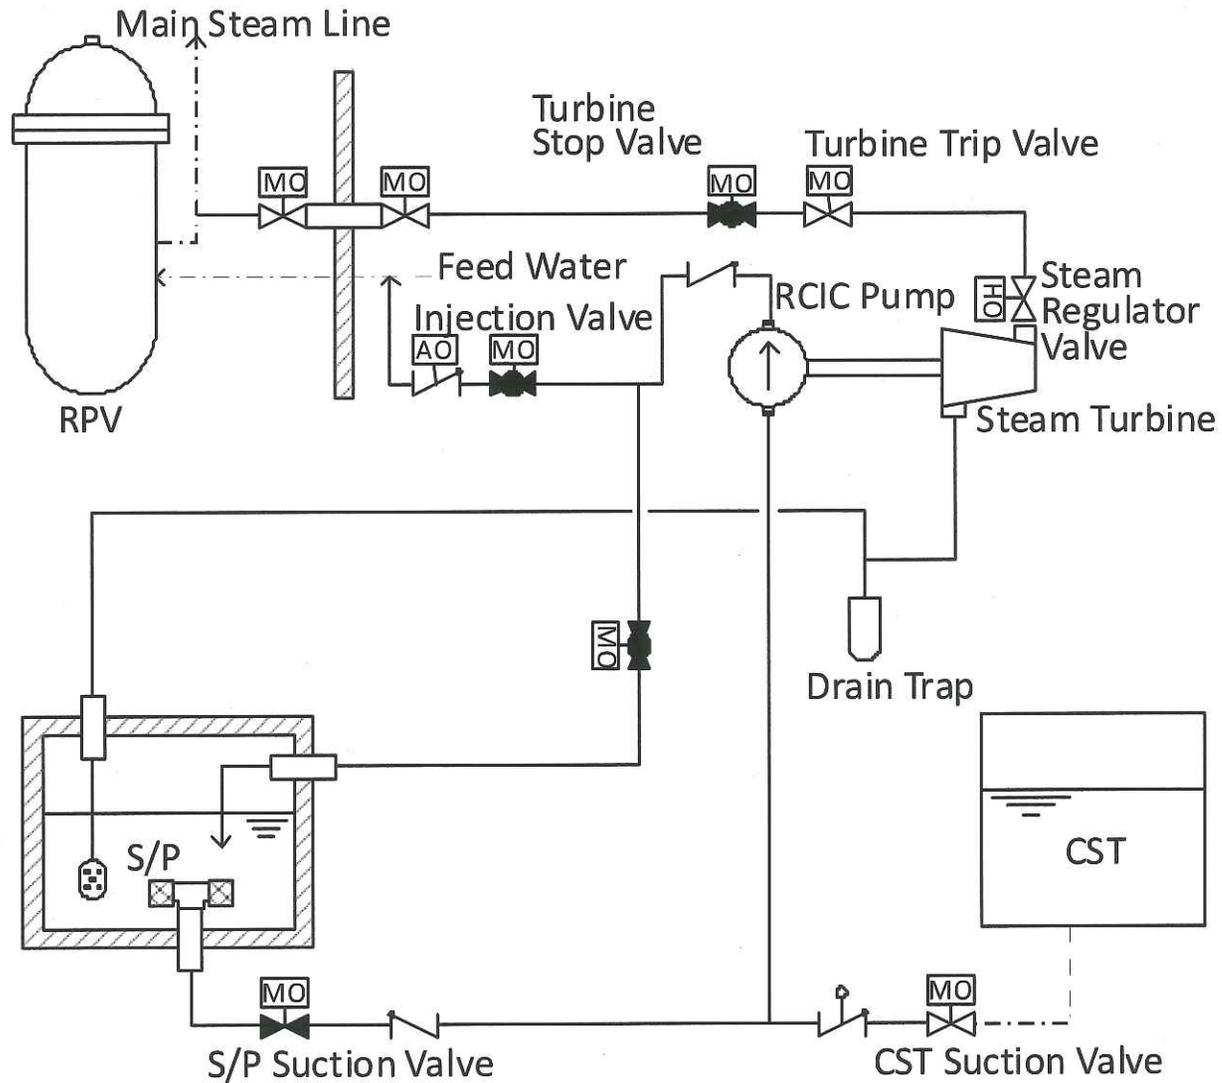
Schematic of RCIC*

Design Features of RCIC (Unit 2, 3)

Item	Description
Purpose	<ul style="list-style-type: none">• Inject water into RPV during isolation event (MSIV closure)
Function	<ul style="list-style-type: none">• After reactor isolation, sends reactor steam to RCIC Turbine, which injects water into RPV• Condensed reactor steam (drained water from RCIC Turbine) is discharged to Suppression Pool
System configuration	<ul style="list-style-type: none">• Turbine, Pump, piping, valves, water sources (CST and S/P) [see next slide]• Auto start at RPV low water level (L2), then stop at RPV high water level (L8)• Primary water source is CST then switch to S/P when reaching high water level (+5 cm NWL) in S/P• All valves and governor in turbine pump can be operated by DC power
Capacity	<ul style="list-style-type: none">• RCIC can operate without AC power using DC power only for 8 hours depending on load reduction in an SBO

*HPCI (High Pressure Core Injection System) was also available as AC independent system

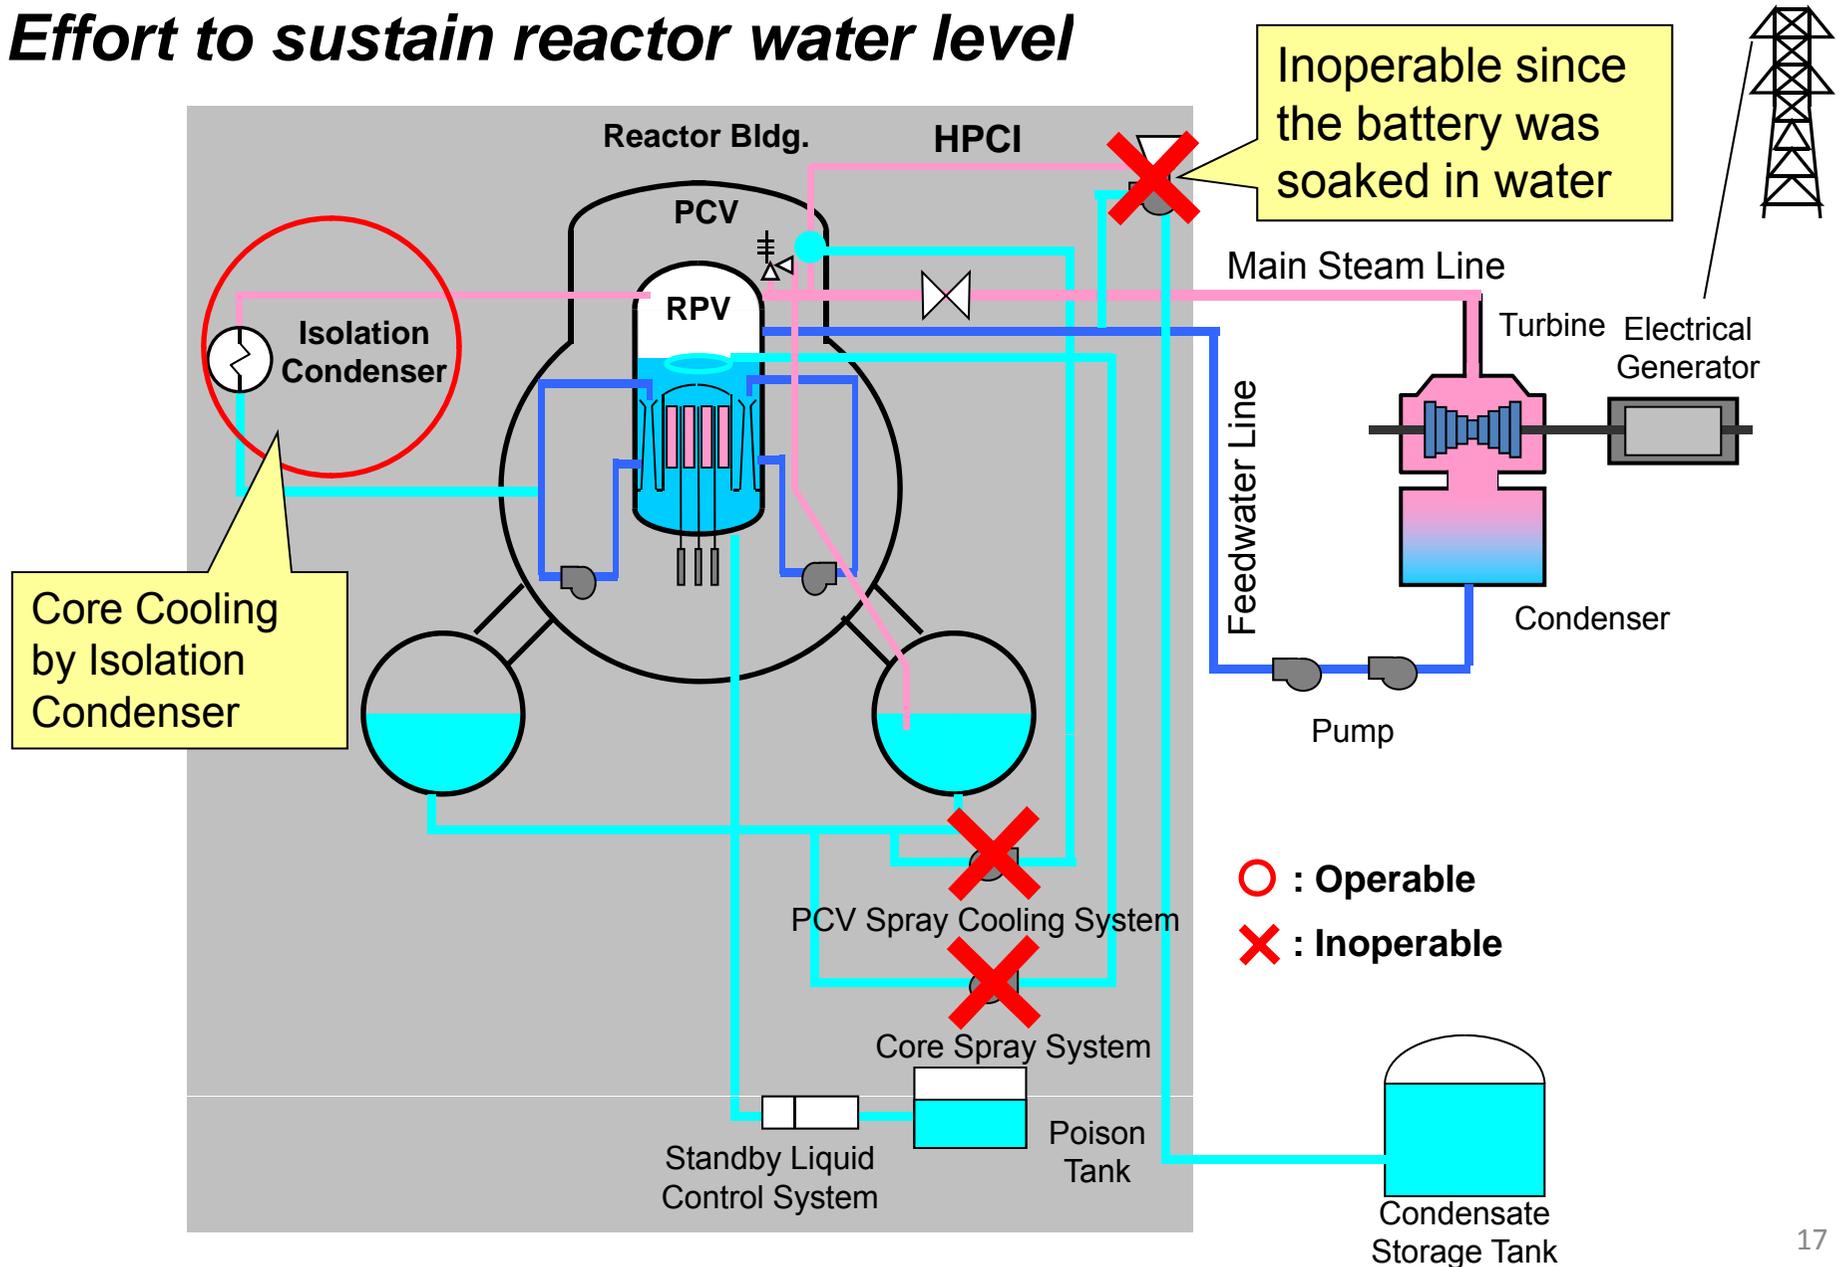
3-7. Major event progression at Unit 1 (1/4)

Effort to sustain reactor water level

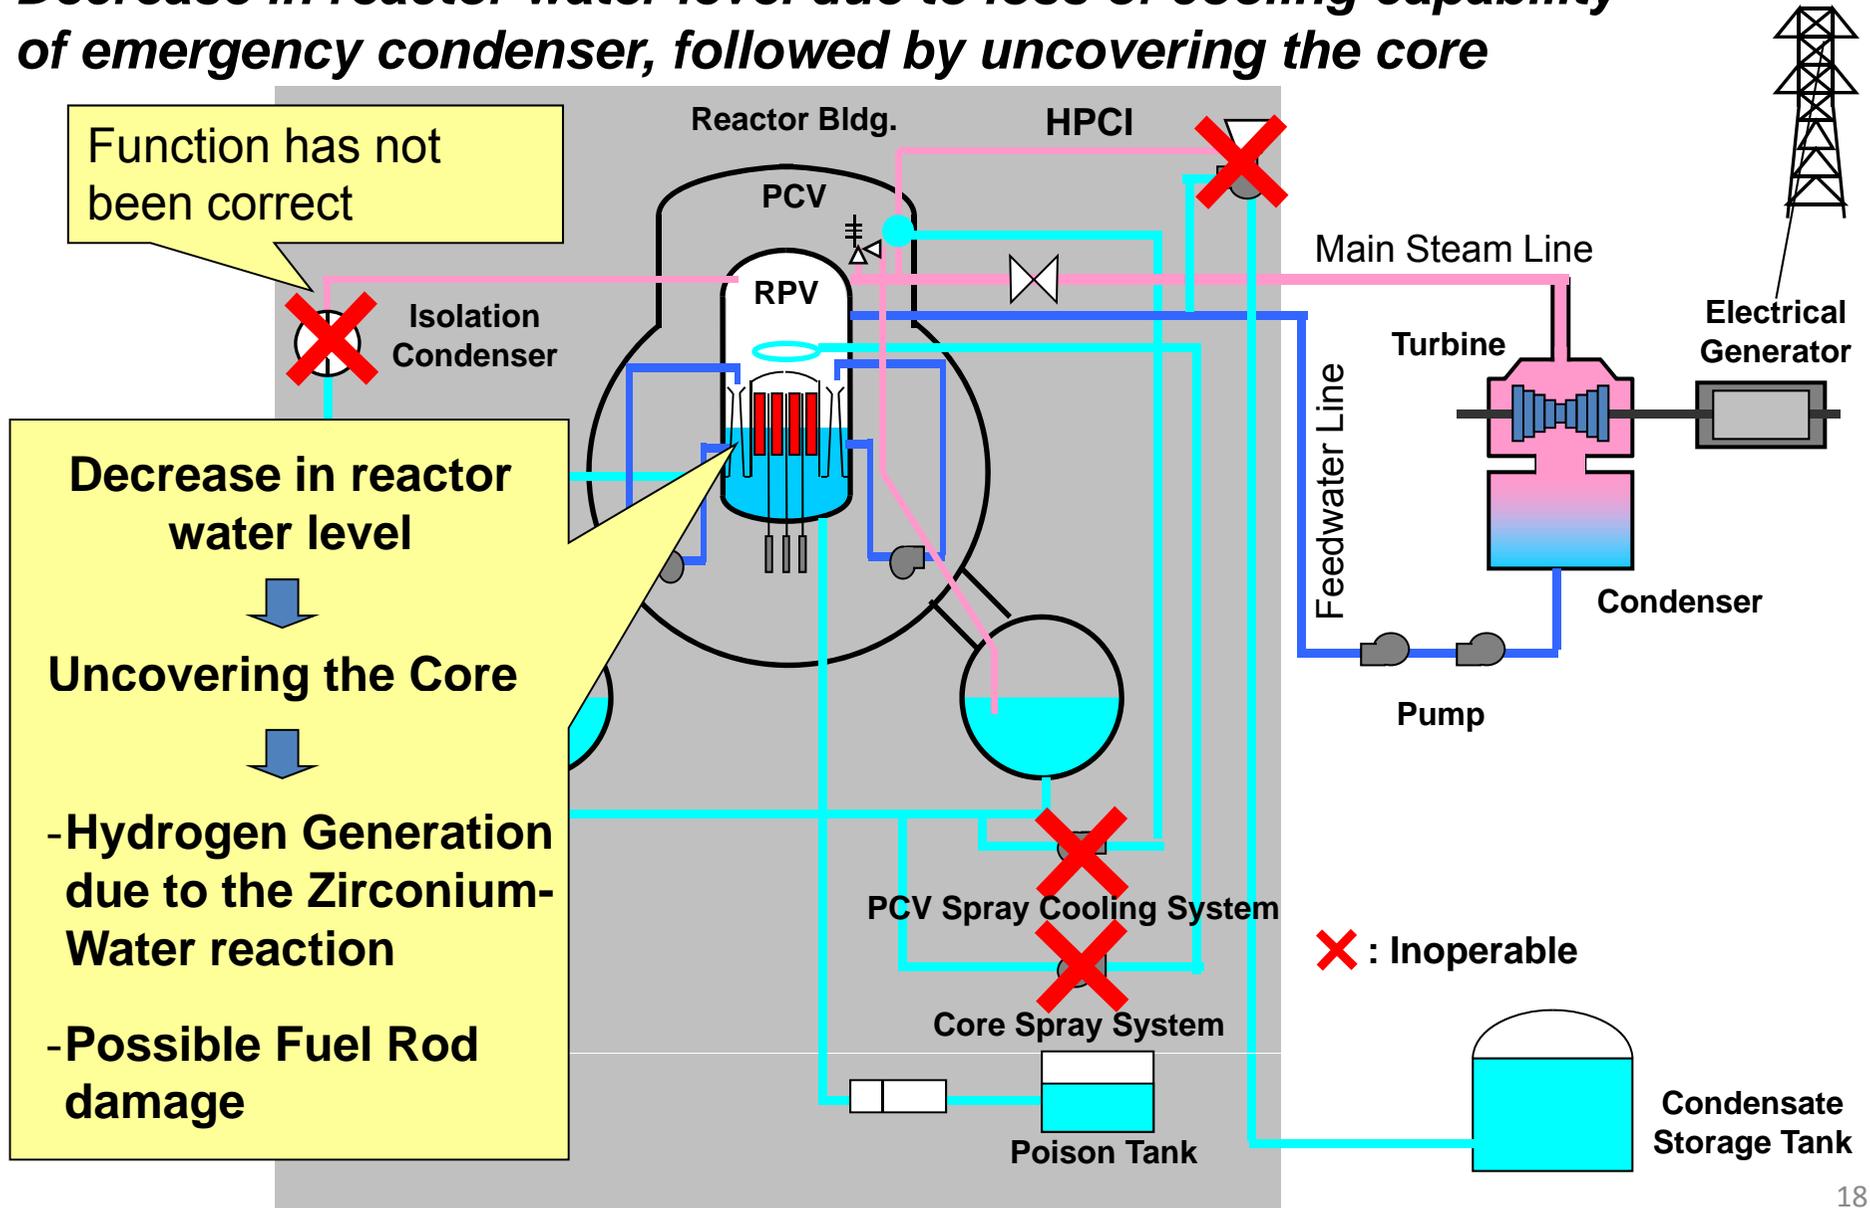
3-7. Major event progression at Unit 1 (2/4)

Decrease in reactor water level due to loss of cooling capability of emergency condenser, followed by uncovering the core

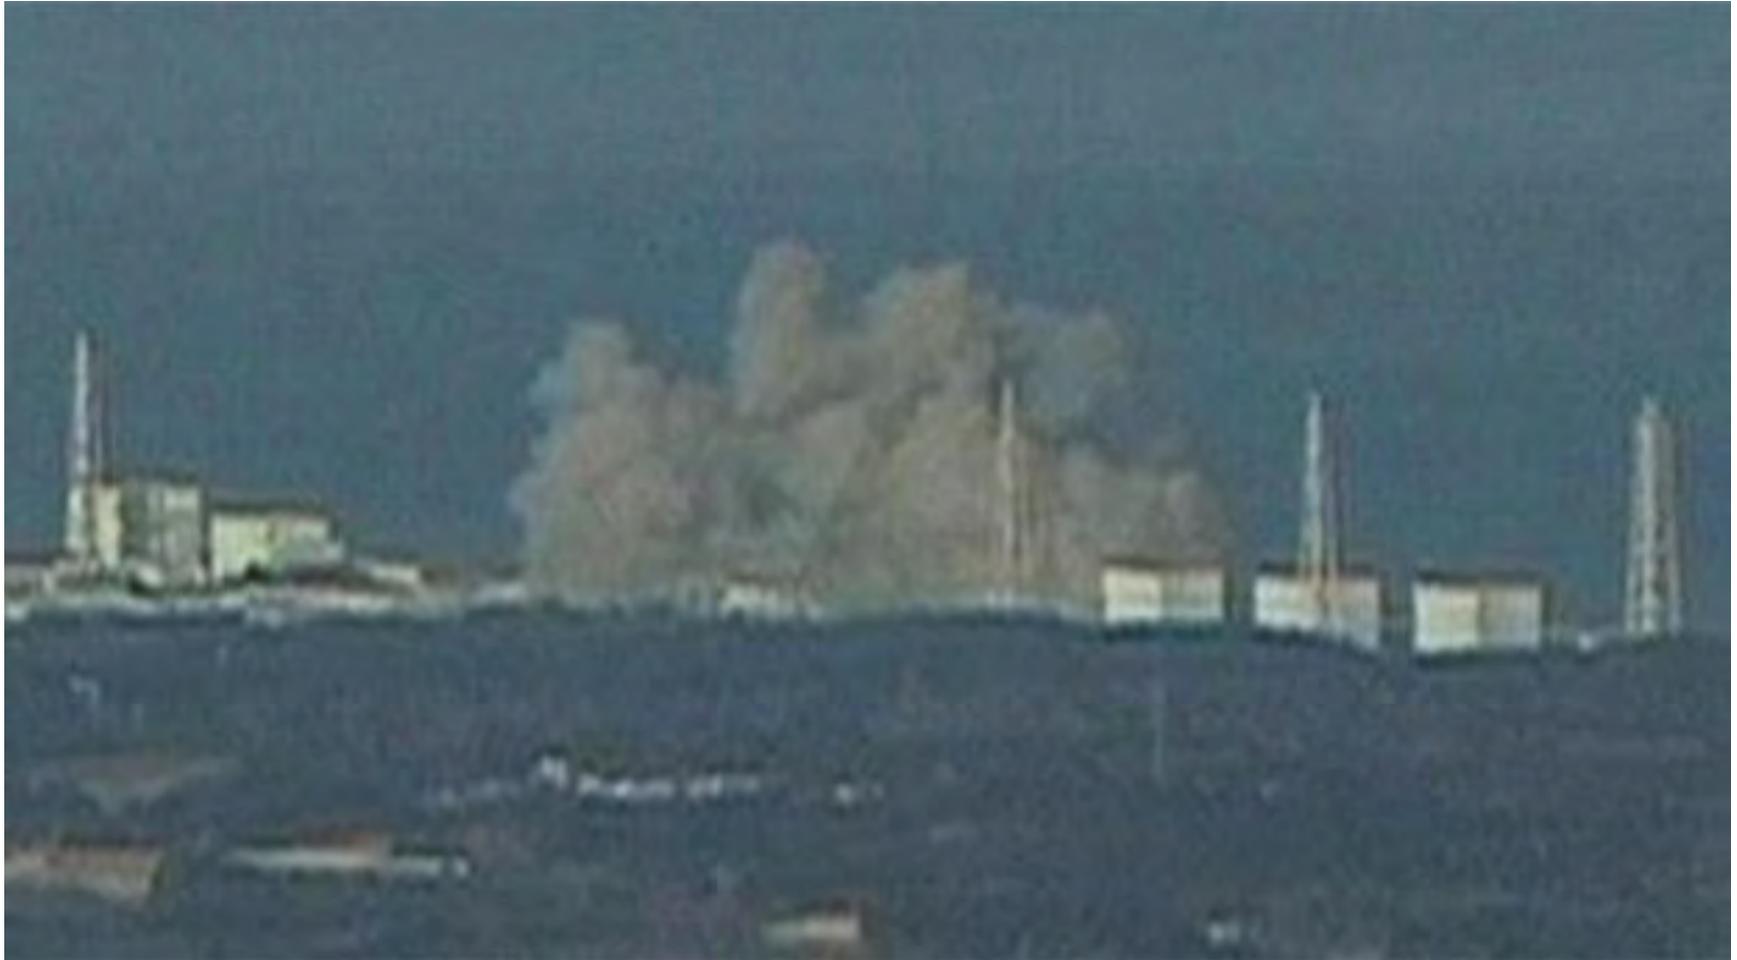
3-7. Major event progression at Unit 1 (3/4)

Unit 1 Explosion

Hydrogen explosion in the operation floor

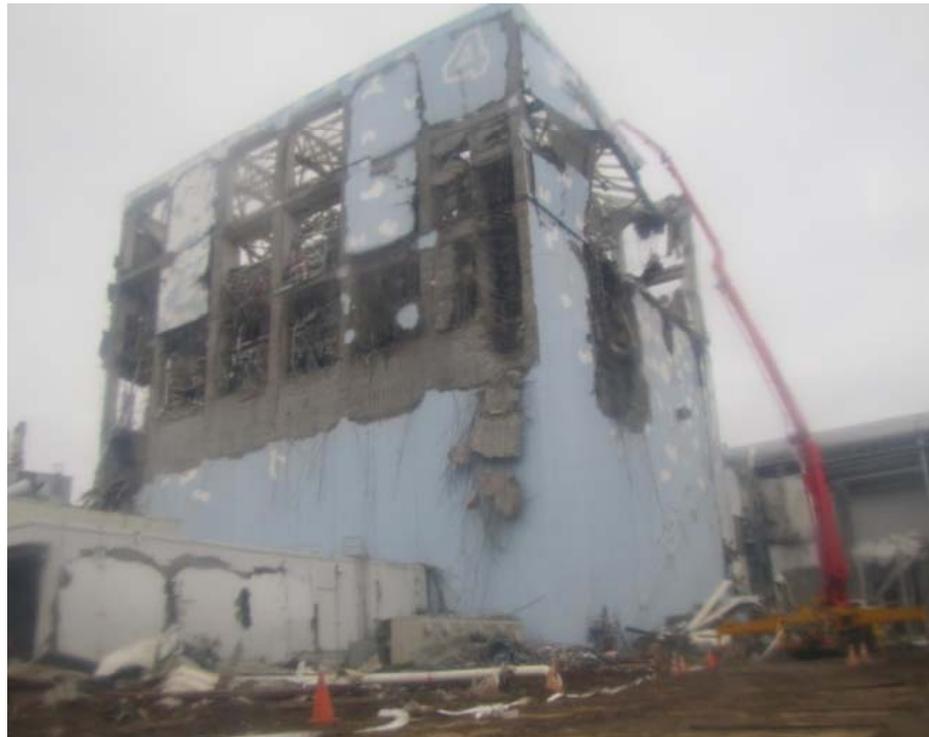
Photo: Water spray into the SFP in Unit 4 using concrete pump truck

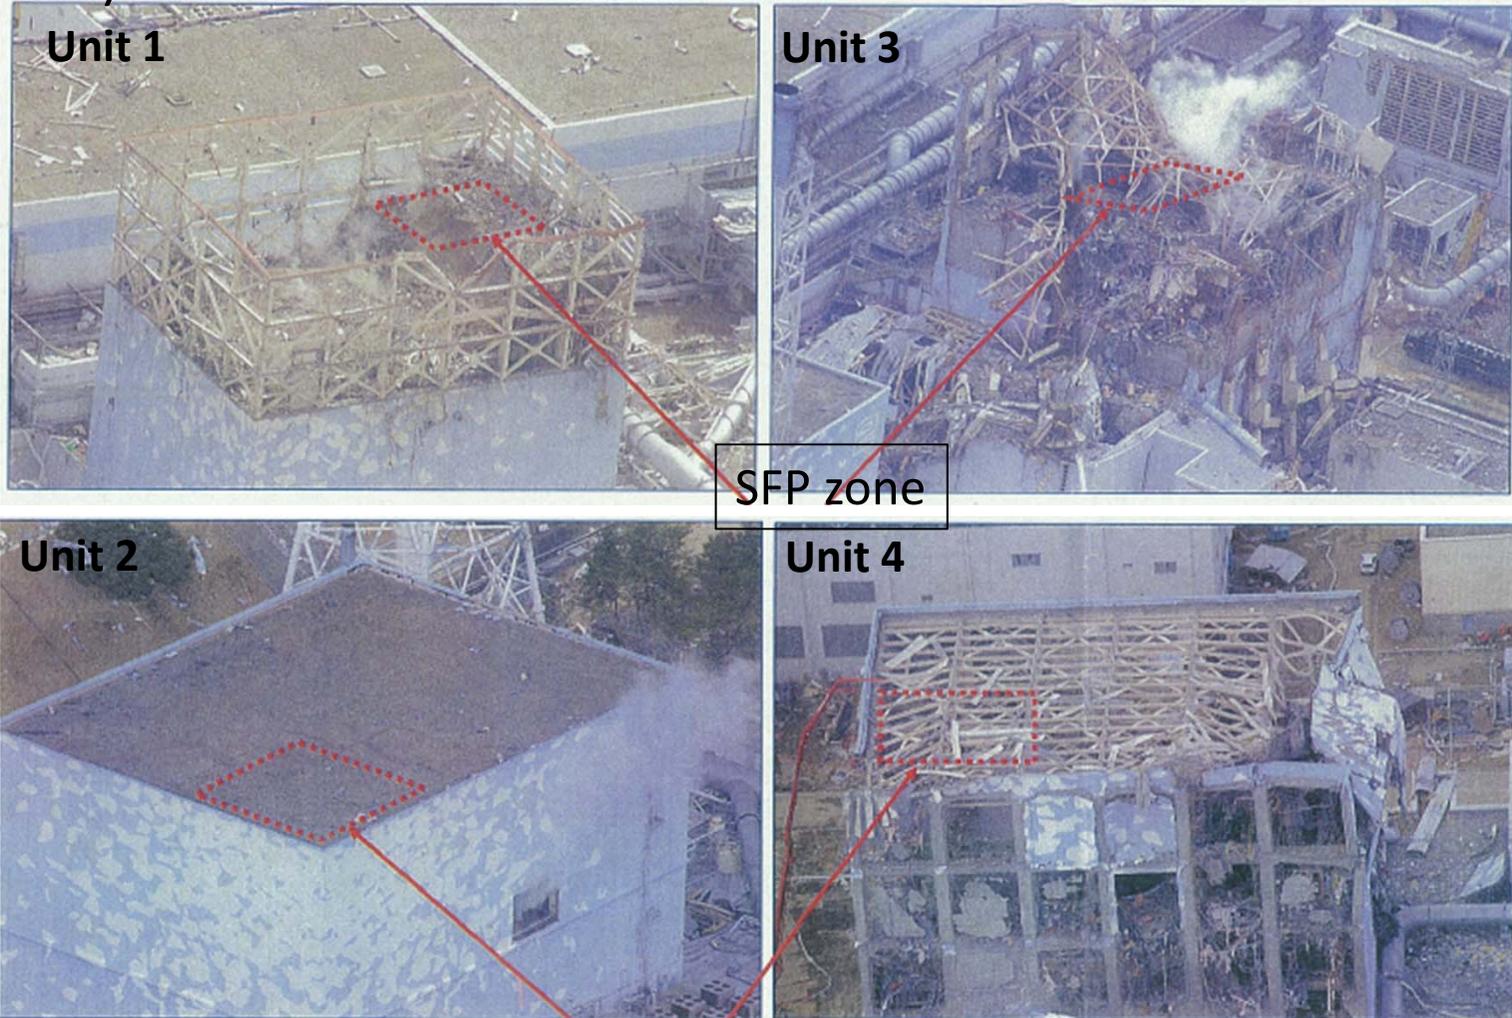
Why H₂ explosion right after venting?

Possible Path 1 : Excessive leakage by over-pressure at CV flange/airlocks
Possible Path 2: Vent line → SGTS → R/B (vent line merge with adjacent unit's line)

1F2 blowout panel opened by
1F3 blast, which released H₂

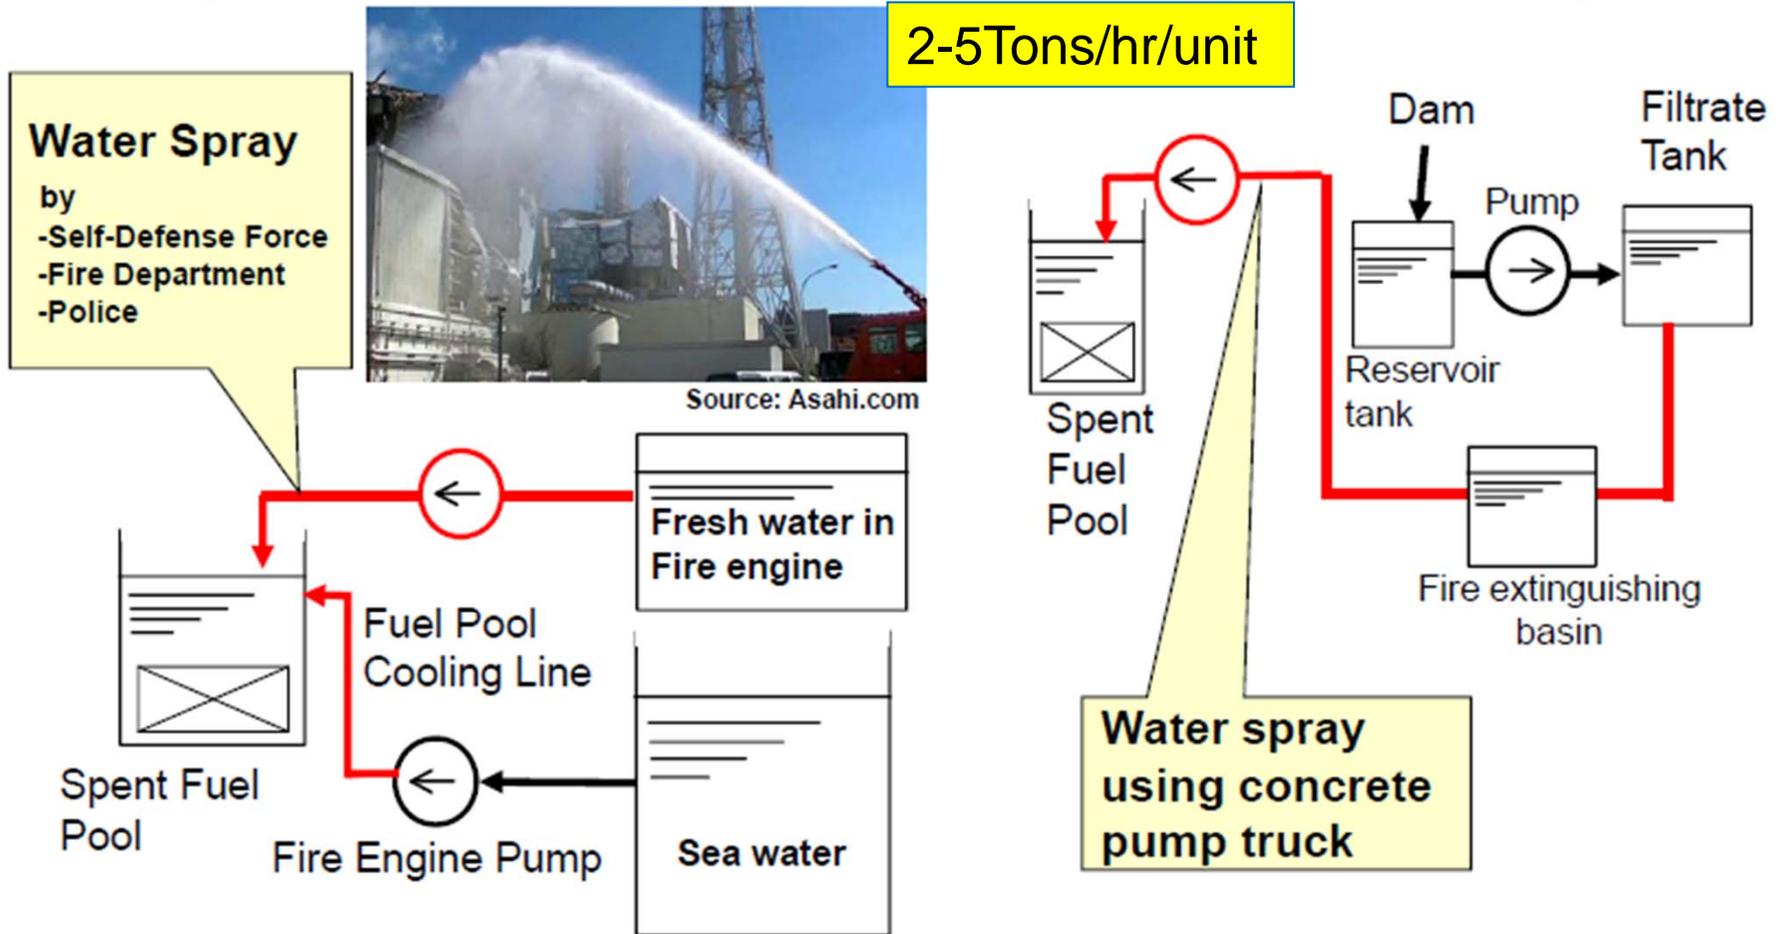
Current : Water Injection to SFP (Spent Fuel Pool)

【1st Stage】 Sea water injection

【2nd Stage】 Fresh water injection

1F1,3, 4: Similarly by occasional spray from above
1F2: Using FPC-MUW (w/o overhead spray)

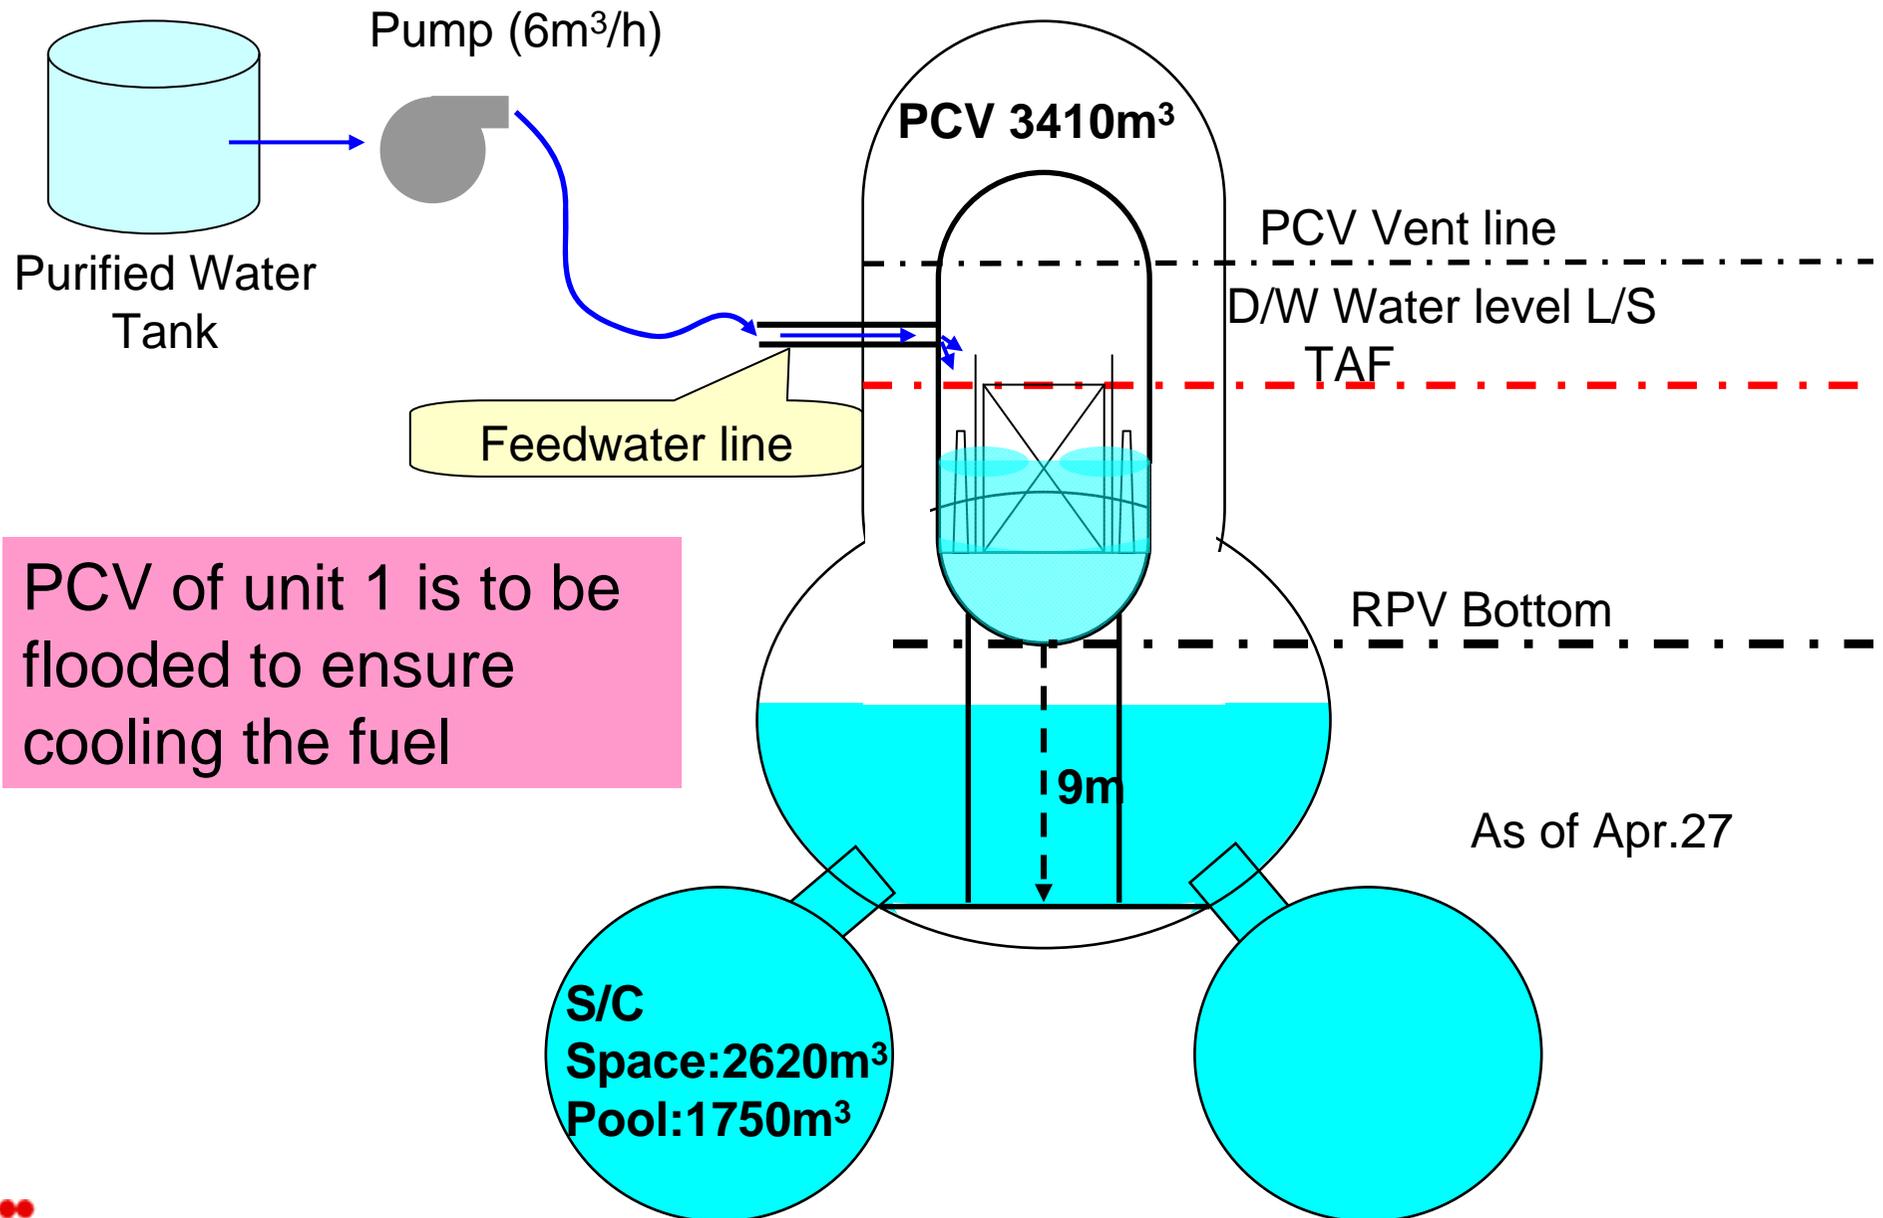
PCV Flooding (unit 1)

PCV of unit 1 is to be flooded to ensure cooling the fuel

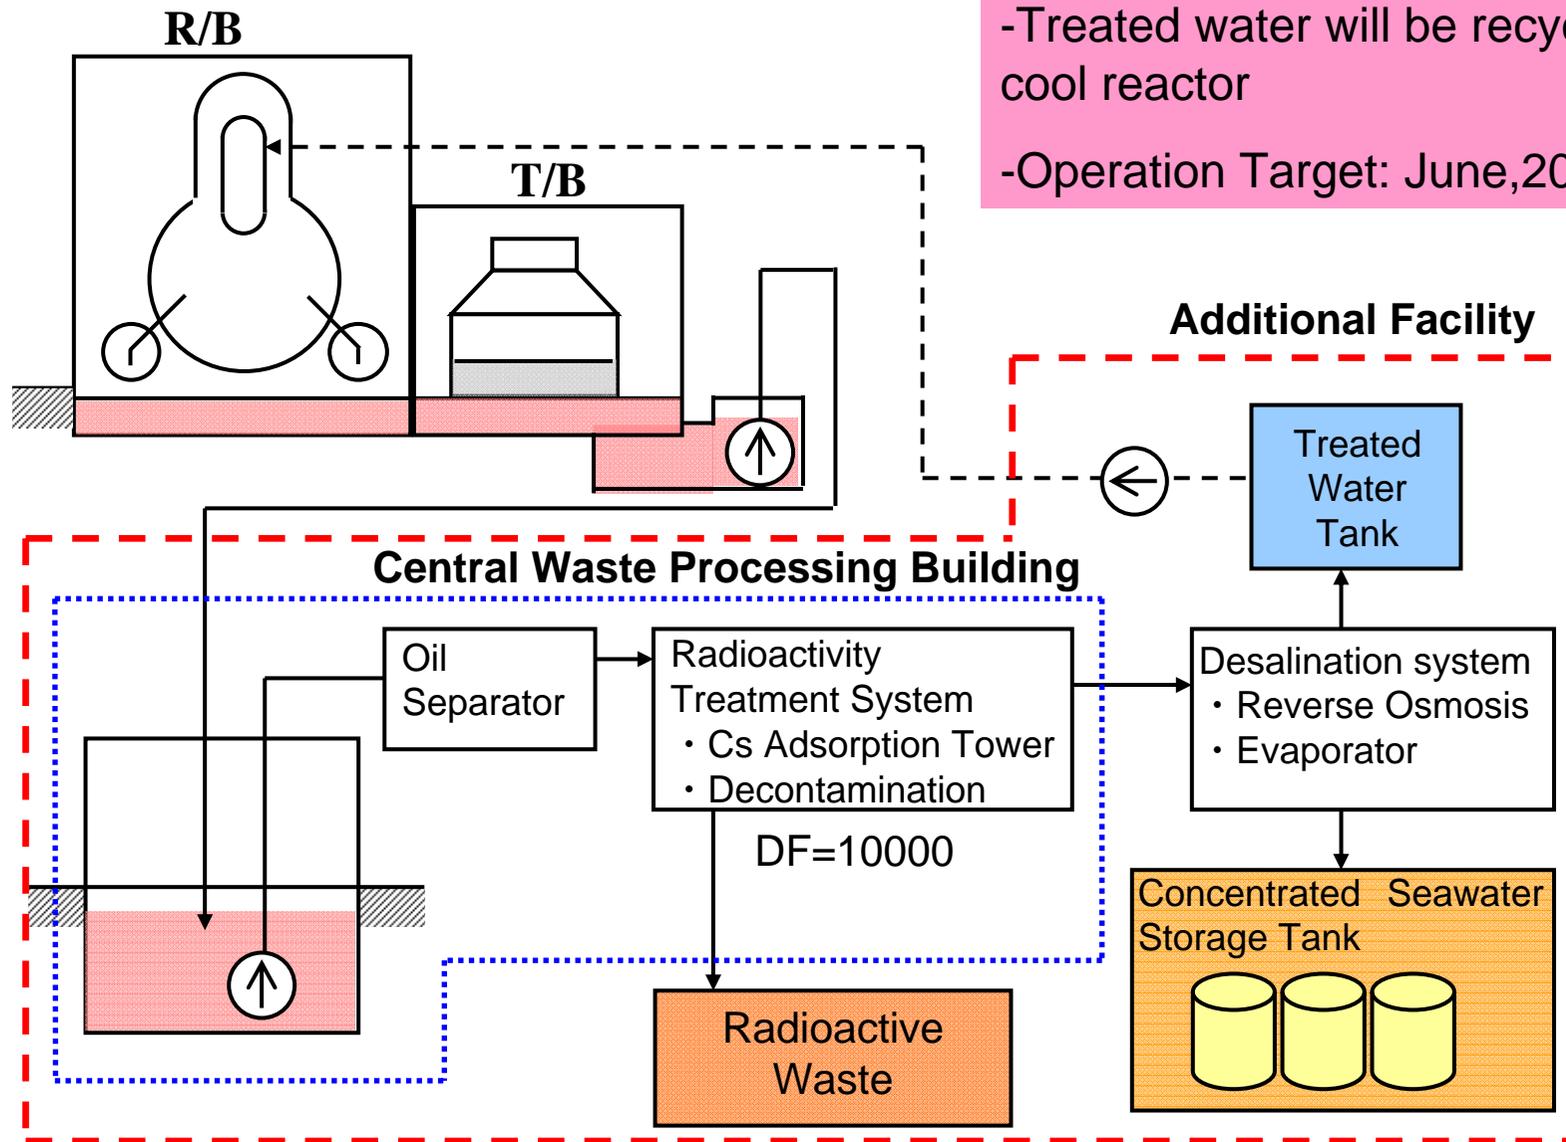
Installation of Water Treatment Facility

-Treated water will be recycled to cool reactor
-Operation Target: June,2011

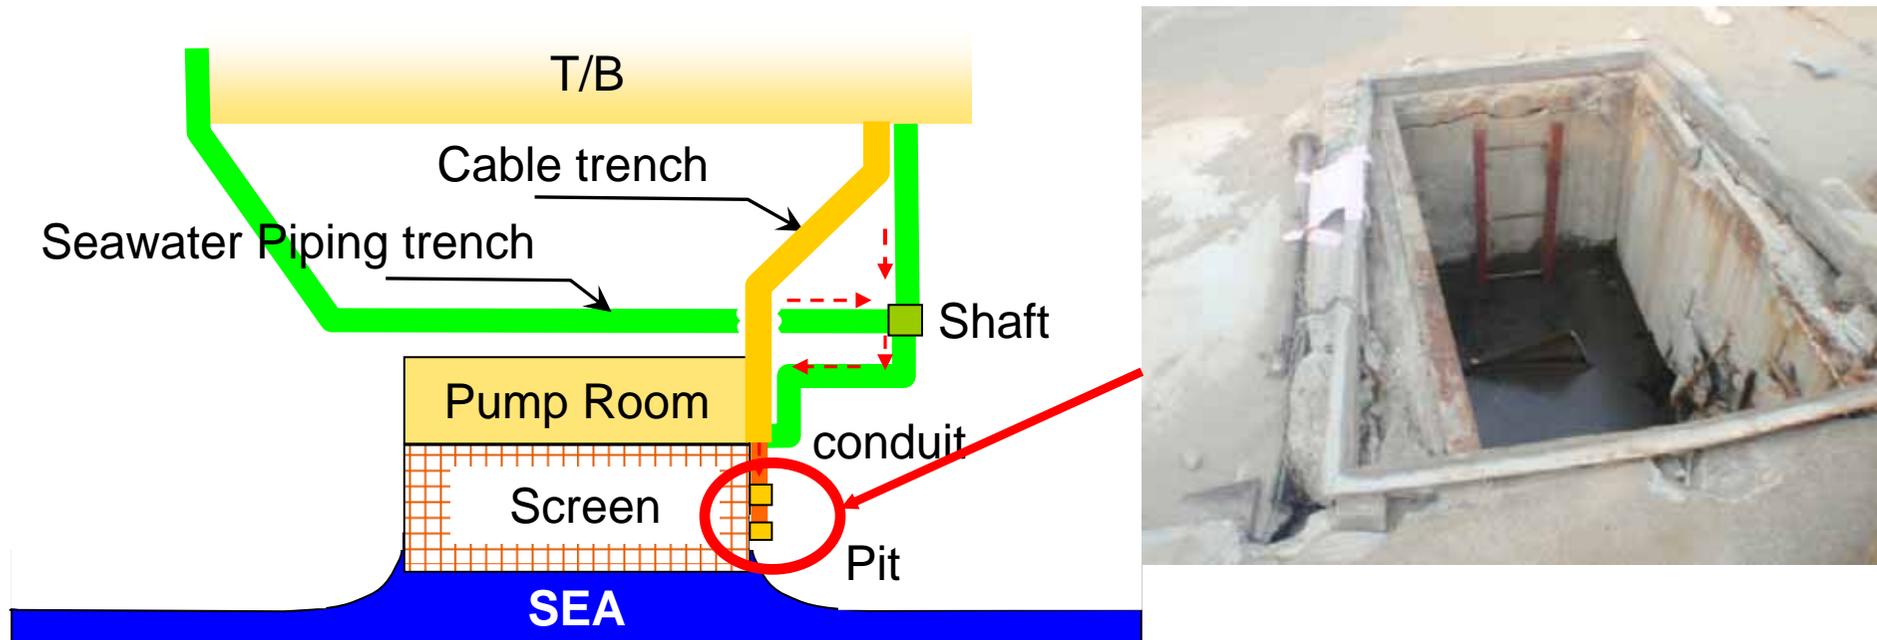
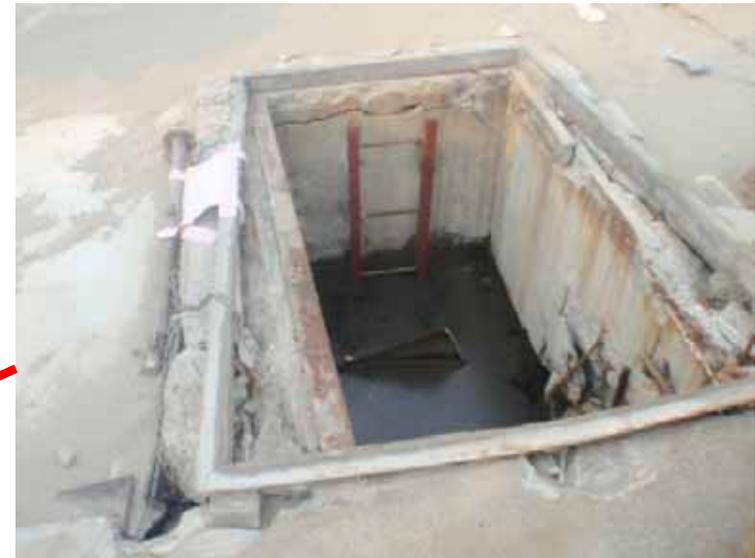
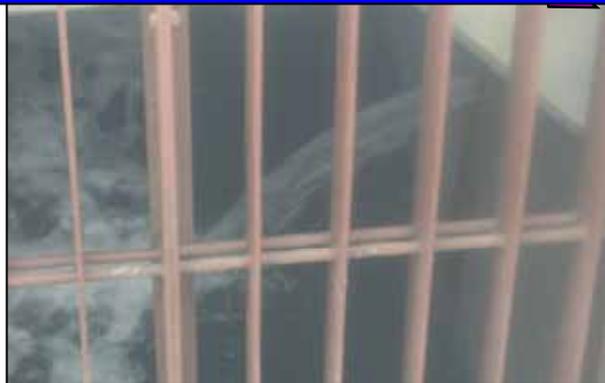
Highly contaminated water was found to leak into the sea through crack in the cable pit on Apr.2.

Dose rate : more than 1,000mSv/h

Radioactivity : $\begin{cases} \text{I-131} & 5.4 \times 10^6 \text{ [Bq/cc]} \\ \text{Cs-134} & 1.8 \times 10^6 \text{ [Bq/cc]} \\ \text{Cs-137} & 1.8 \times 10^6 \text{ [Bq/cc]} \end{cases}$

Prevention of contaminated water spill

Injection of coagulant successfully plugged water path on Apr.6.
Total radioactivity released was estimated to be 4.7×10^{15} Bq

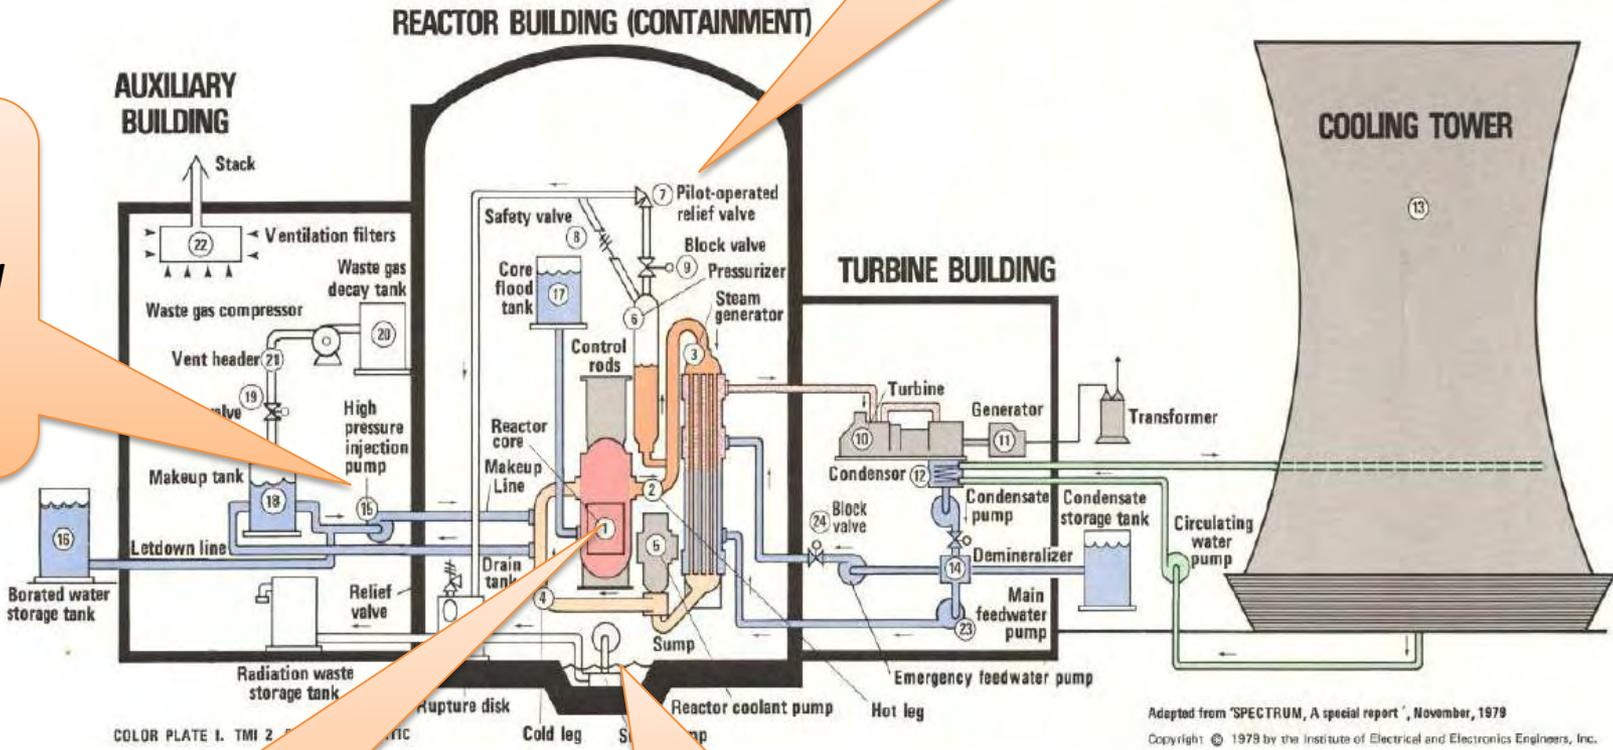
Three Mile Island Unit-2 Accident

Operators Believe Reactor Overfilled and Turn Off Injection Pumps

Relief Valve fails to close

Core is uncovered Fuel overheats/fails/~50% Melt

650,000 gallons of highly radioactive water collects
